IV. Analysis of Existing Conditions

The South Capitol Gateway and Corridor Improvement Study began with the *Existing Conditions Analysis*, completed in early 2003. This document includes technical data that underscores the need to make fundamental changes to South Capitol Street's transportation infrastructure.

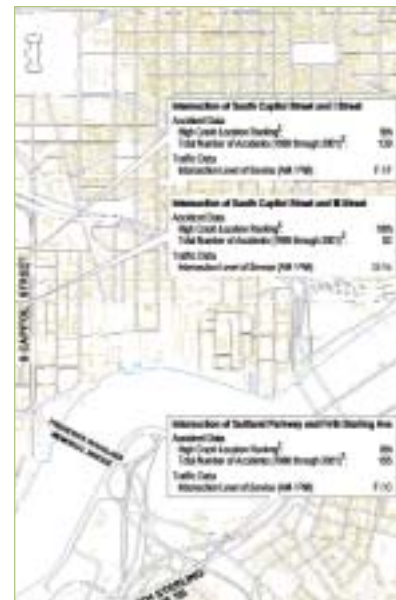
Diagram showing problem intersections along the South Capitol Street corridor

Eye Street is the first local street that crosses South Capitol beyond the freeway ramps. The disconnection between it and the elevated, arterial ramps is typical of the study area's cross streets. Although this intersection carries large traffic volumes, there is not sufficient room for vehicles to merge where the ramps reach street level. Southbound traffic from the freeway encounters a traffic signal and a right-turn-only lane at this point. Northbound traffic passing through must weave across several lanes in a short distance to reach the freeway entrance ramp.

Inadequate signage and narrow lanes contribute to the hazards this intersection, which is ranked the ninth worst in the District of Columbia for its high volume of right-angle and rear-end collisions. The ramps that channel such large volumes here also interrupt the sidewalks and obstruct access to nearby neighborhoods.

Although traffic that merges from I-395 to South Capitol is brought to an abrupt halt at Eye Street, it is immediately encouraged to accelerate as South Capitol approaches M Street and dips beneath it. Narrow lanes, poor pavement condition, and short sight distances contribute to this intersection's ranking as the 18th worst accident location in the District of Columbia.

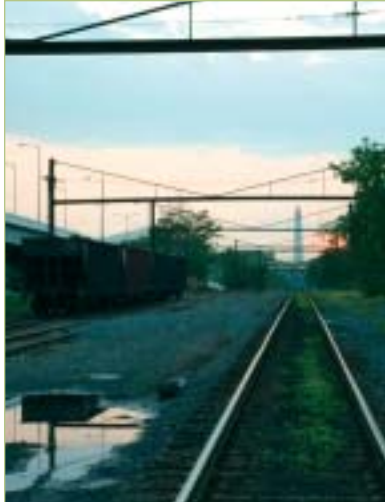
Train tracks along the Virginia Avenue alignment with Washington Monument to the northwest

The first indicator of South Capitol Street's inability to function as an urban boulevard is the elevated railroad track just two blocks south of the U.S. Capitol Grounds. Constructed in the 1880s by the Pennsylvania Railroad, this infrastructure cuts through the Capitol Hill neighborhood and continues on the old Virginia Avenue alignment to the northwest. This railroad track set the precedent for future highways to follow it.

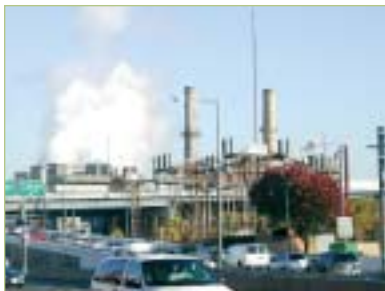
Abandoned substation from the Pennsylvania Railroad near the intersection of South Capitol and Eye Streets SE

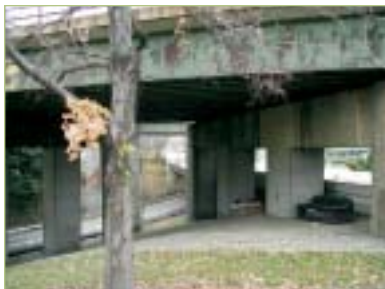
View underneath Southeast Freeway's elevated ramps

Underutilization of land is also clear underneath the freeway ramps. Since they were designed exclusively to carry arterial traffic, the ramps prohibit any other land uses. The residual space below them is a dark and dangerous wasteland.

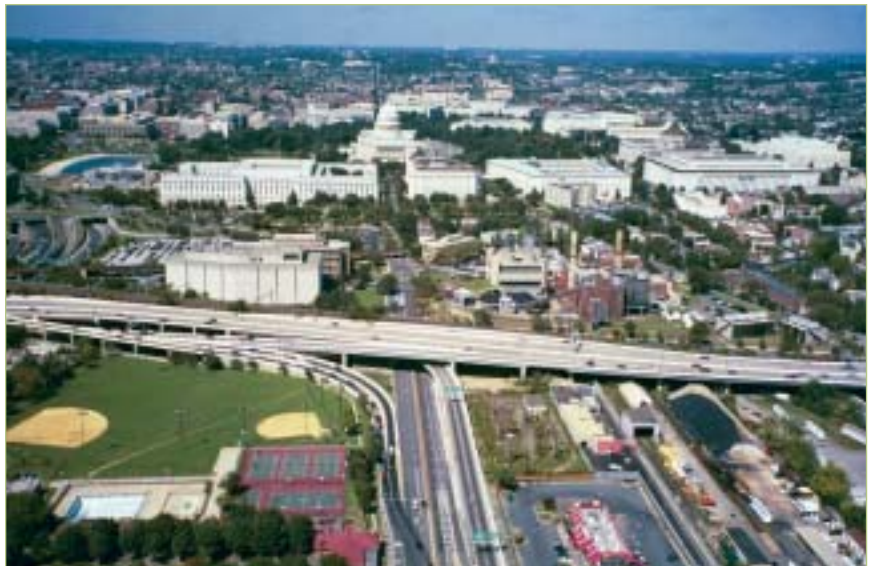
Aerial view of South Capitol Street and Southeast Freeway with U.S. Capitol to the north

An aerial view of South Capitol Street's north end indicates even more clearly how the corridor has been overwhelmed by elevated transportation infrastructure. Just a few blocks south of the Capitol, Interstate 395 creates a massive wall that separates Capitol Hill from the city to the south.

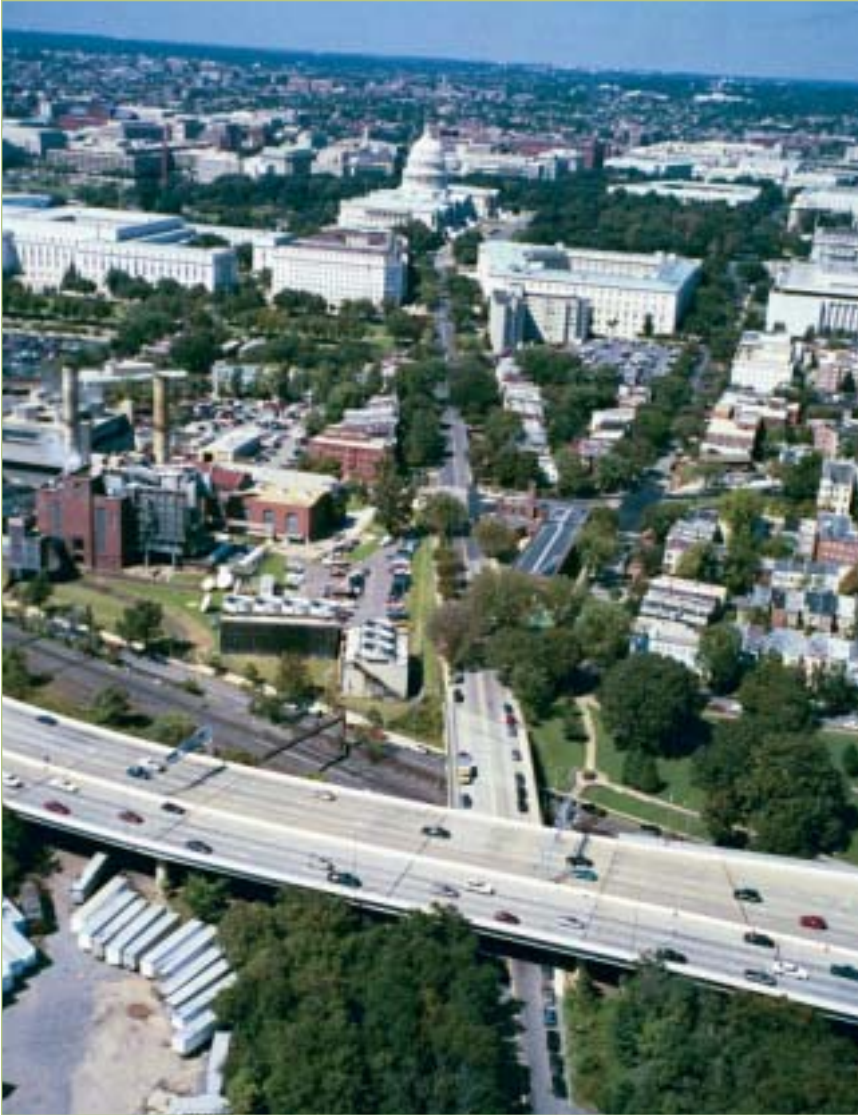
Aerial view of New Jersey Avenue SE and Southeast Freeway

A closer view of the freeway from above suggests how the land on both sides of South Capitol Street is underutilized. Because the freeway's construction required demolishing hundreds of buildings, its path of destruction was far wider than the highway's right-of-way. In addition to the land taken by eminent domain, residents and businesses fled the area in anticipation of the project's negative impact on the neighborhood. The subsequent disinvestment has kept the corridor economically stagnant for nearly half a century. The intervention of the highway also prompted the closing of many streets, which hinders movement within and between local neighborhoods.

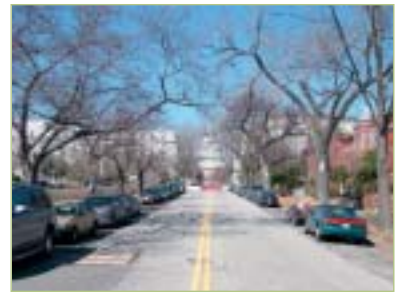
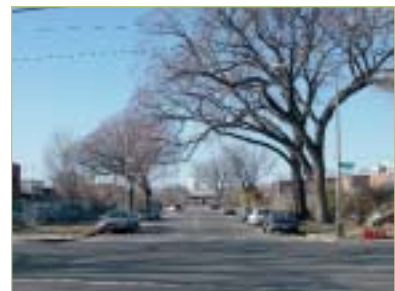
New Jersey Avenue SE north of Southeast Freeway

New Jersey Avenue SE south of Southeast Freeway

The bleak condition of South Capitol Street is paralleled by that of New Jersey Avenue to the east. New Jersey Avenue also demonstrates how radically the freeway construction transformed adjacent neighborhoods. Above I-395, Victorian rowhouses fronted with wrought iron fences line the tree-lined avenue. The barren area immediately south of the freeway is dominated by parking lots and abandoned buildings, further evidence of the area's chronic disinvestment.

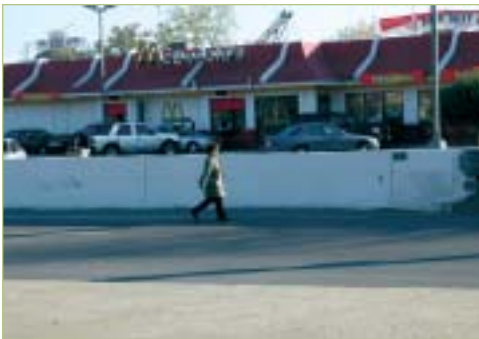
Pedestrian walking along South Capitol Street near Eye Street SE

Because South Capitol Street is formally designated as a freeway in the District's roadway system, cross streets have been blocked to reduce the number of intersections. Narrow sidewalks, the absence of trees, the lack of on-street parking and the speed of passing vehicles further discourage bicyclists and pedestrians.

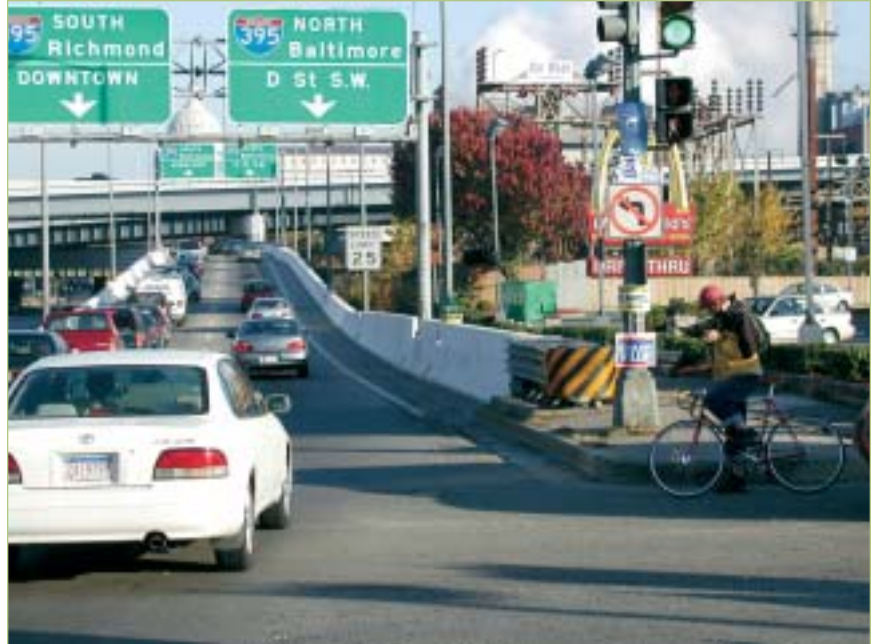
Cyclist attempting to turn onto South Capitol Street from Eye Street SE

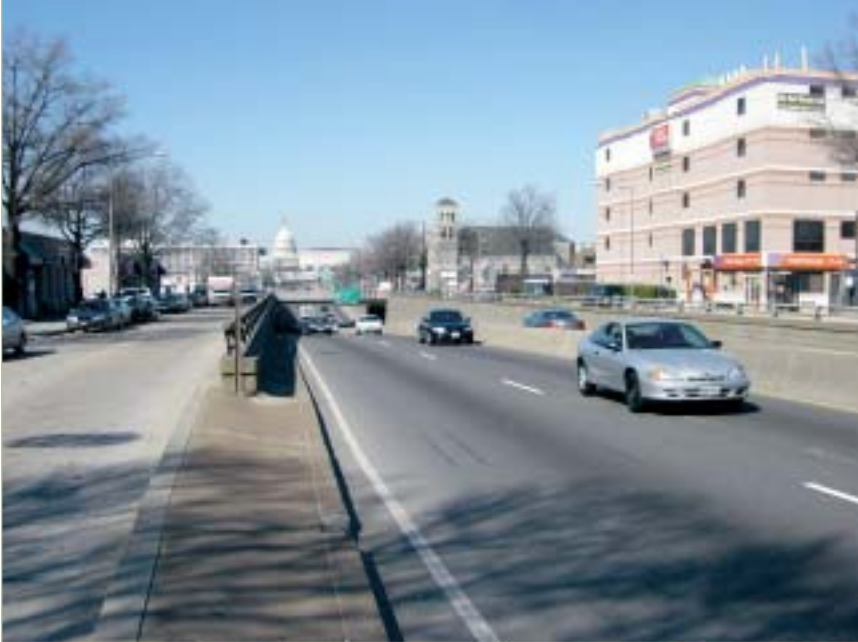
South Capitol's underpass below the intersection at M Street

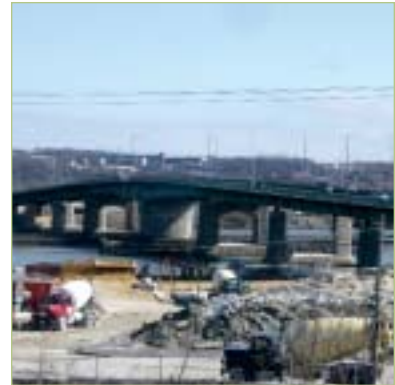
Concrete plant east of South Capitol Street along the Anacostia River

The bleak conditions for pedestrians and cyclists continue along South Capitol Street to the Frederick Douglass Memorial Bridge. This has the effect of extending the corridor's arterial character east of the Anacostia River. Pedestrians and cyclists share the narrow, five-foot walkways on both sides, but at their peril. The bridge's height and urbanistically insensitive design have prohibited development in its vicinity. The few industrial businesses located near the bridge handle concrete, gravel, asphalt, and waste.

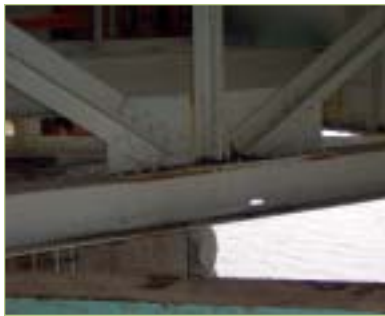
Douglass Memorial Bridge steel section loss

Built in 1949, the Frederick Douglass Memorial Bridge is in poor condition and will soon require replacement. The District Department of Transportation plans to carry out minimal rehabilitation to extend the bridge's life approximately fifteen years.

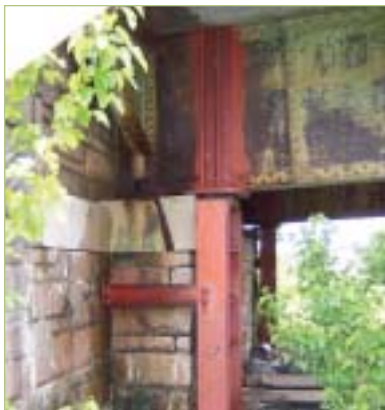
Douglass Memorial Bridge failed bearing plate at south-east abutment

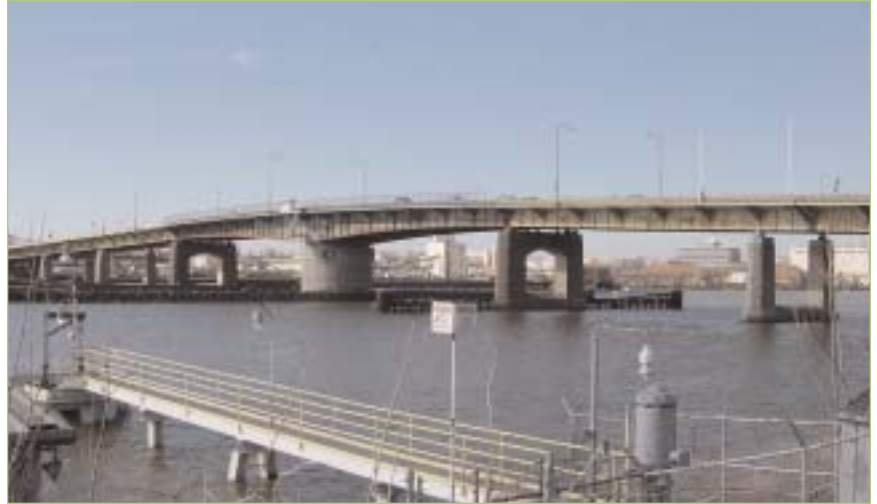
Frederick Douglass Memorial Bridge looking toward the Navy Yard from the east of the Anacostia River

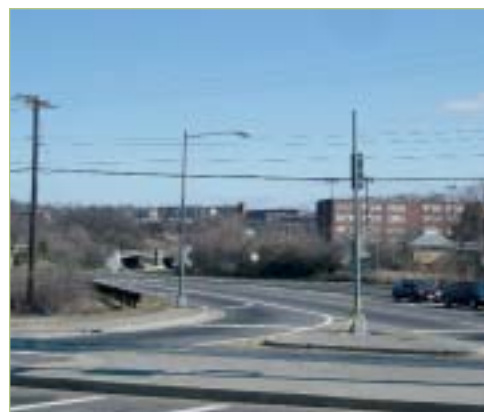
Portion of the I-295 and Suitland Parkway Interchange

Situated east of the Anacostia River, the interchange of South Capitol Street, Suitland Parkway, and I-295 is a complex maze of ramps and connector roads. The interchange is functionally deficient, confusing to use, and unattractive. Roadways that should provide access to the waterfront block it instead.

The I-295 interchange includes unnecessary and duplicate roadway connections. These inefficiencies and redundancies consume several acres of land. The complexity of the interchange makes it difficult for drivers to navigate, a problem compounded by inadequate signage. Although complex, the interchange is also incomplete. There is no ramp between southbound I-295 and northbound South Capitol Street. Howard Road substitutes for this missing link conducting traffic onto a local street.

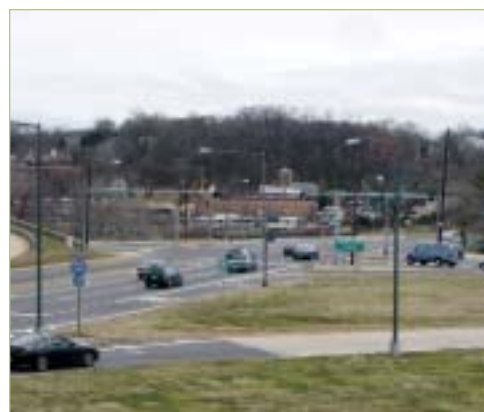
Intersection at Firth Sterling Avenue and Martin Luther King, Jr. Avenue, which has the highest fatality rate in the District of Columbia

Two streets, Firth Sterling Avenue and Martin Luther King, Jr. Avenue, provide the only access across Suitland Parkway in this area. The intersection of the Suitland Parkway and Firth Sterling Avenue forces high-speed traffic from the parkway to stop. The sight distance for approaching traffic is short and signage is inadequate. These factors cause it to be the intersection with the 8th highest accident rate in the District. More importantly, it has the highest fatality rate of any District intersection. Rear-end accidents are the most common. Accidents involving pedestrians are especially frequent. MLK is grade separated from the parkway, so it allows safe crossing but this intersect permits no access between the neighborhoods and the parkway.
